2.2.3 PUMPING STATION KORTENHOEF

Besides pumping station Dooijersluis pumping station Kortenhoef has also recently been renovated and has been equipped with fish-friendly archimedian screws (FishFlow Innovations). Waternet wanted to evaluate the effect of the fish-friendly archimedian screws in the autumn of 2014.

3.6 Monitoring of passage through pumping station Kortenhoef

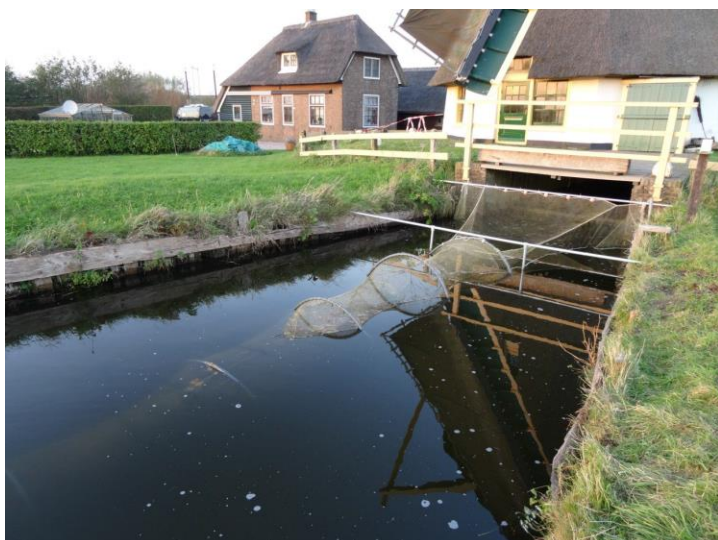
- ♣ Customised frame + fyne net at the outflow of the pumping station / mill to encompass the entire outflow from the pumpingstation/mill (see Figure 3) the mesh size is 13-11-9 half mesh;
- ♣ Fish stock fyke nets (2 wing fyke nets with a 125 mesh design with a mesh size of 13-11-9 mm for each half mesh with a synthetic cover so that no damage can be caused by crabs whereby catch could be lost);
- ♣ Materials required during monitoring such as measuring boards, live nets, bowls etc .;
- ♣ Boat to be used for the emptying of the pumping station and fish stock fyke nets, if required.

Figure 3: Example of a tailored fyne net and frame, location: warer mill De Onrust

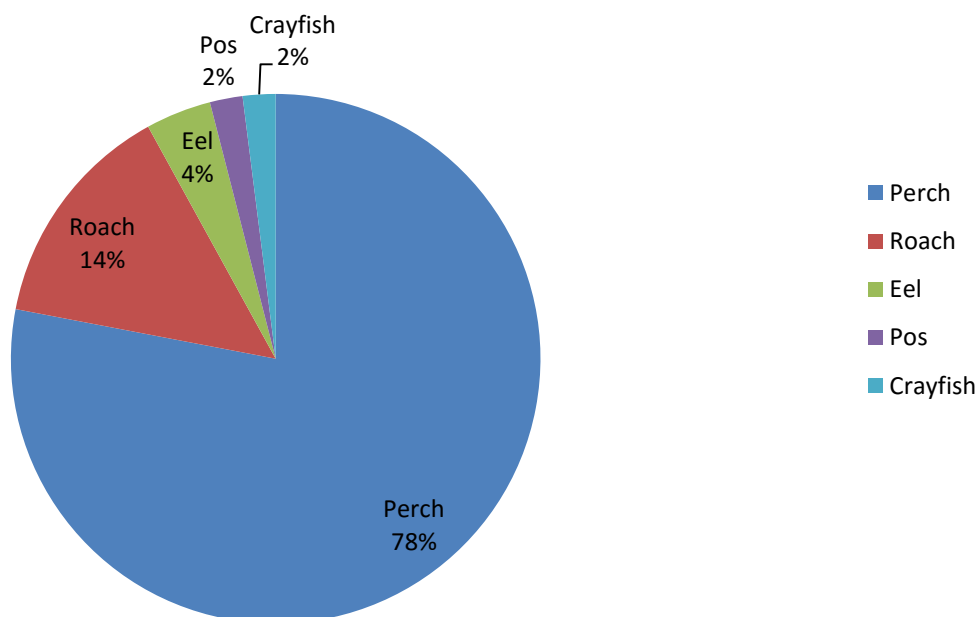
Figure 13. Species composition of the fish stock

In total 4 fish species and crayfish have been caught during the monitoring of the fish stock. The fish species caught were perch, roach, eel and pos. The fish stock catches were dominated in numbers by perch, with 78% of the total (Figure 13).

The kind of compositions in the fish stock catch and the passage monitoring is largely comparable; approximately 75% of perch and approximately 20% roach and approximately 5% other species dominated by eel and pos. This is in contrast with the pumping stations Dooijersluis and Hollands Ankeveen. This may indicate that the fish at pumping station Kortenhoef are only to a limited extent deterred as a result of the use of a silent archimedian screw. Therefore the strong swimmers may not be inclined to turn back whereas they do turn back at other pumping stations.

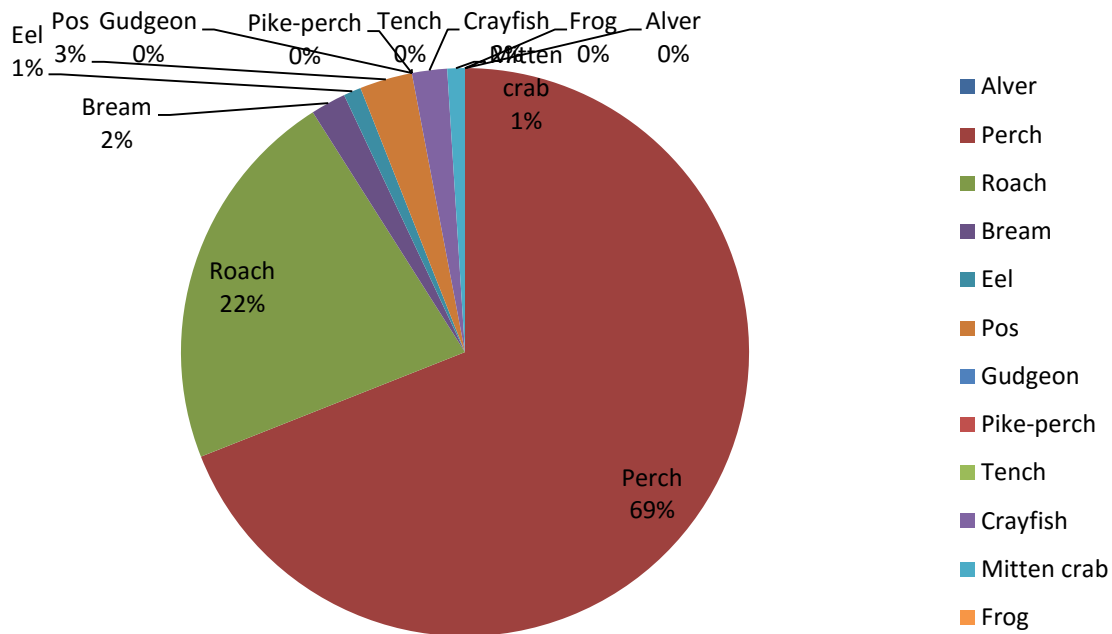
In total 9 fish species, cray fish, mitten crab and frog have been caught during the monitoring of the passage through pumping station. The fish species consisted of alver, perch, roach, bream, eel, pos, gudgeon, pike-perch and tench. The perch dominated in numbers with 69% of the total catch (figure 11)

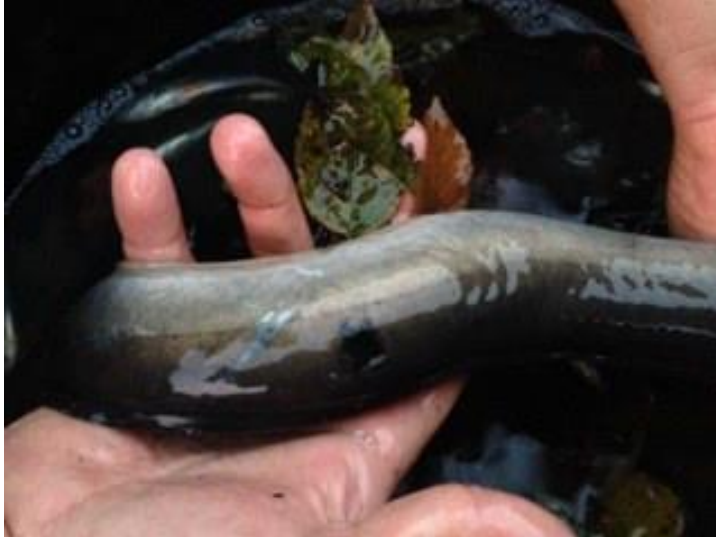
In table 12 the number damaged and dead fish is shown. The number of damaged fish is very small (0.1%). In total 1 eel was damaged. This was of the “snap damage” type and it is suggested that it has been caused by a pumping station or ship propeller. (figure 18).

Figure 18 Eel with snap damage pumping station Kortenhoef

The damage and mortality table of pumping station Kortenhoef shows that hardly any damage of fish has been noted. The number of damaged fish is negligible (0.1%). In total 1 eel with snap damage has been observed. The percentage of damage is well below the generally accepted damage percentage of maximal 5%. No dead fish have been observed.
